Streamflow data in Arequipa, Peru

Authors: L. Bowling, A. Moraes, K. Cherkauer, F. Daneshvar, J. Frankenberger, E. Bocardo, & J. Pinto

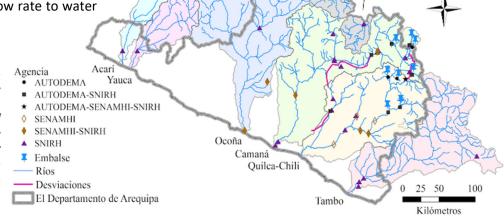
Figure 1. Locations of river discharge monitoring stations in the Arequipa Department, Peru. These locations are differentiated based on frequency and the type of measurement taken (daily or hourly flow). Rivers, large diversions, and dams are also identified in the map.

River discharge has been monitored in 40 unique locations in seven watersheds that overlap with the Arequipa department (Figure 1). It is measured by several regional and local agencies which make up the National Water Resources Information System (Sistema Nacional de Información de Recursos Hídricos – SNIRH) who distributes the data.

Adequacy: The overall station density shown in Figure 1 is reasonable, but stations were either installed to estimate flow potential for later reservoir construction, or to monitor current water transfer through the system. No active stations were identified with a drainage area less than 1000 km². Small natural upland gauged catchments are needed in order to distinguish climatedriven changes in the frequency and magnitude of floods or droughts from those due to more immediate and direct anthropogenic causes. In addition, flash floods are a concern in many areas around Arequipa, but there have been no gauging stations historically that can help to quantify flood hazard in these small watersheds. The short span of data collection and high percentages of missing data, and flow alterations caused by upstream regulations, limit the potential for long-term hydrological analysis in Arequipa. Only three of the stations identified have record lengths greater than 20 years and are still active.

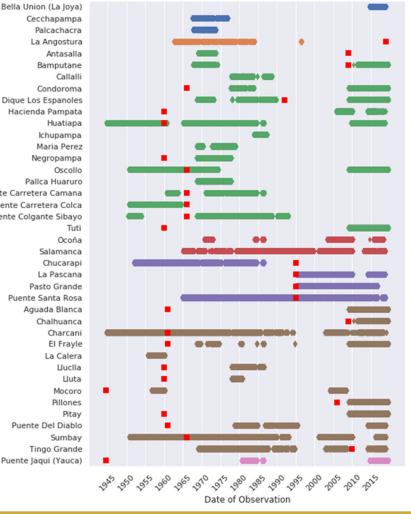
Figure 2. Dates of river discharge observations and start of upstream flow regulation (red square), for all streamflow stations in the Arequipa Department of Peru. Color indicates river basin in which each station is located. For stations downstream of multiple structures the red square shows the date of earliest regulation. If start of regulation predates 1944 then it is plotted as occurring in 1944 so that it appears on the figure.

Stream discharge monitoring in Arequipa started with one station in 1923; more consistent streamflow data collection started in the 1960's (Figure 2). Many stations were established to quantify resources in rivers that have since been regulated; these early stations have been discontinued over time. Currently, daily stream discharge is actively being monitored in 22 locations in Arequipa. Six of these stations are part of water management infrastructure controlled by AUTODEMA and represent regulated discharge from reservoirs. Nine hourly monitoring stations (three represent new locations, six coincide with existing stations) were installed in 2014 and 2015 but are currently only reporting river stage and cannot be used for hydrologic analysis until a rating curve is established.
